PROCEEDINGS
OF THE MERCHANT MARINE COUNCIL

UNITED STATES COAST GUARD
Vol. 19, No. 10 • October 1962

PROCEEDINGS

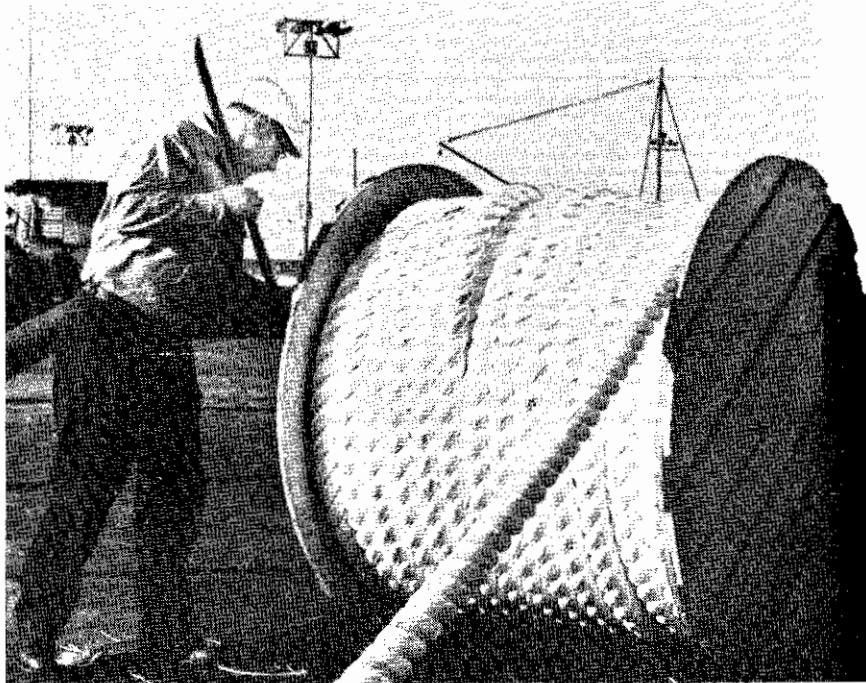
The seaman, experienced in his profession, was handling the port off-shore bow mooring line. This 6-inch line, manufactured of synthetic fibers, led from a bollard on the dock through the port rolling chock to the forward bitts, aft to a fairlead abaft the windlass and thence to the gypsy head of the windlass. The seaman standing forward of the gypsy head and facing aft had placed four round turns on the gypsy head and was tending the line. The starboard bowline was being tended in a similar manner. A heavy strain developed on each of these lines as both were being used to heave the vessel ahead to the next berth. However, the starboard bowline was momentarily surged when its turns became fouled on the gypsy head and thus caused a critical load to be put on the port bowline. Although these lines are capable of being stretched far beyond the limits of hemp fibers, the elastic limit in this instance was exceeded and the line parted between the gypsy head and the fairlead. Unlike hemp fibers, no inherent audible warning is given as the line approaches its breaking point, and once the line parts or the tension is released, the tendency of its fibers to return to their original shape creates a terrific backlash. This occurred as the port line parted. The length of the line attached to the bollard whipped violently out of the fairlead and although unobserved by the others on the bow, it apparently struck the seaman before disappearing overboard thru the rolling chock. When discovered the lower extremities of both legs had been so severely mangled as to necessitate amputation.

Although synthetic fiber lines have many characteristics that make them superior to hemp fibers, there are certain precautions that must be exercised in their safe handling. Supervising personnel should carefully consider the lead of the line to be employed so as to reduce or eliminate, if possible, the positioning of any personnel in the potential "line of fire" from a parting line. This consideration should be given even though use of such a lead may not be the most satisfactory or convenient with respect to rigging stoppers, securing the line, etc.

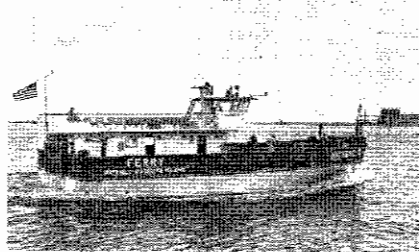
M/V NICHEVO II

A new combination passenger and automobile ferry, the Motor Vessel *Nichevo II*, was completed recently at Fraser-Nelson Shipbuilding & Dry Dock Co., Inc., Superior, Wis., for Nichevo Ferry Line, of LaPointe (Madeline Island), Wisconsin.

The hull is reinforced at bow and stern to withstand operation in ice and to allow for numerous dockings in regular service.

Power for the ship is supplied by a 250 h.p. Murphy Diesel engine driving a four-bladed propeller through three-to-one reduction gearing. Designed speed of the ship is 12.5 m.p.h.

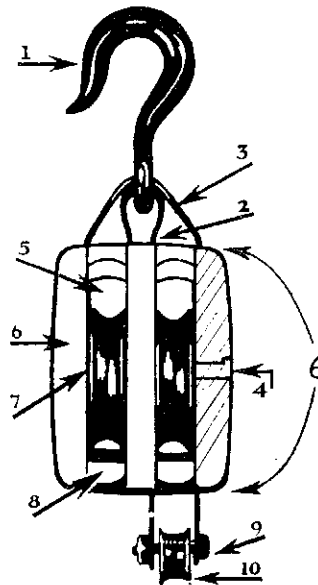
Q. Name seven of the ten parts of a block indicated on the diagram below:

- A. (1) Hook
 (2) Inner strap or thimble
 (3) Outer strap
 (4) Pin
 (5) Swallows
 (6) Cheeks or shell
 (7) Sheaves
 (8) Breech
 (9) Becket
 (10) Thimble
